StorageWorks Array Controller

HSJ40 Array Controller Operating Firmware V1.2 Release Notes

Order Number: EK-HSFAM-RN. E01

This document summarizes certain features and limitations of the HSJ40 Array Controller Operating Firmware (HSOF) V1.2 that are not covered elsewhere in the documentation and contains instructions for installing the firmware.

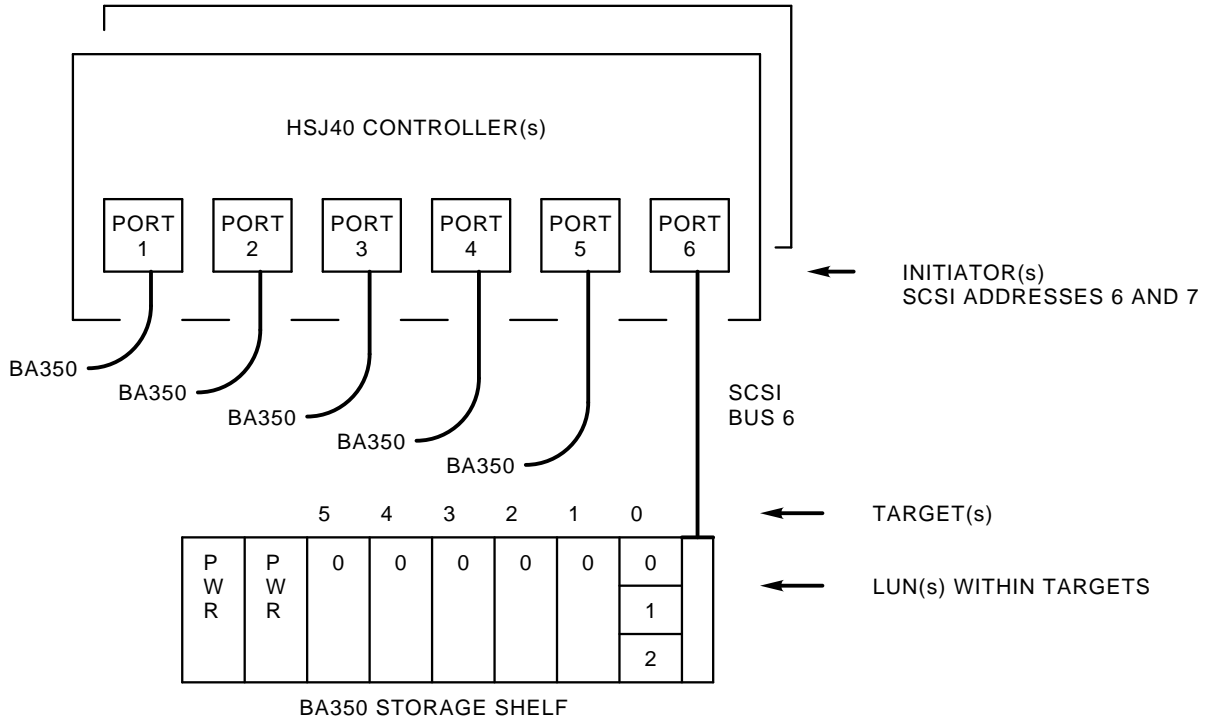
Figure 2 Physical PTL Example

EXAMPLE: THE TARGET AT ADDRESS 0 ON SCSI PORT 6 CONTAINS A DISK DRIVE WITH 3 HDAs. EACH HDA WITHIN THE TARGET DRIVE IS INDEPENDENTLY ACCESSIBLE BY USING ITS PORT/TARGET/LUN ADDRESS.

CURRENTLY ALL DRIVES CONTAIN ONLY ONE DEVICE WHICH IS ACCESSED AS LUN 0.

Figure 2 conveys the difference between ports, targets, and LUNs. It shows a single SCSI bus configuration of target devices in slots 0 through 5, with all target devices configured on port 6. This dual-redundant controller configuration also shows the two controllers at SCSI addresses 6 and 7. (In a vertical configuration the controller nearest the the SCSI cables is SCSI controller ID 6.)

Figure 2 assists in understanding ports, targets, and LUNs. You may also reference the *StorageWorks Family Configuration Guide* (EK-BA350-CG. A02), Table 4–2 (page 4–3).

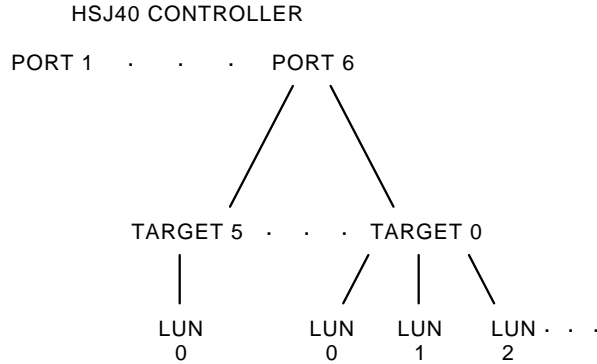
Figure 3 Logical PTL Example

Figure 3 displays the logical relationship between Ports, Targets, and LUNs.
